# The inspection of the triggering mechanism for a hazardous mudflow in an urbanized territory

H. Chen · R. H. Chen · F. C. Yu · W. S. Chen · J. J. Hung

**Abstract** On October 16, 1998, a mudflow of 2,000 m<sup>3</sup> resulting in five deaths in the Neihu area of Taipei city came in the wake of Typhoon Zebert, which delivered approximately 300 mm/day of precipitation. The destructive 50-m-long mudflow rushed down the hill without any forewarning, wreaking severe destruction to the properties below. Based on in-situ investigation, this paper discusses the event scenario and provides critical data analyses to identify the contributing factors and main triggering mechanism of the disaster. The chances of possible water uplift due to groundwater conditions, the engineering properties of the geomaterials, and the influence of man-made changes in the morphology are examined in weighing the importance of these factors and identifying the main trigger.

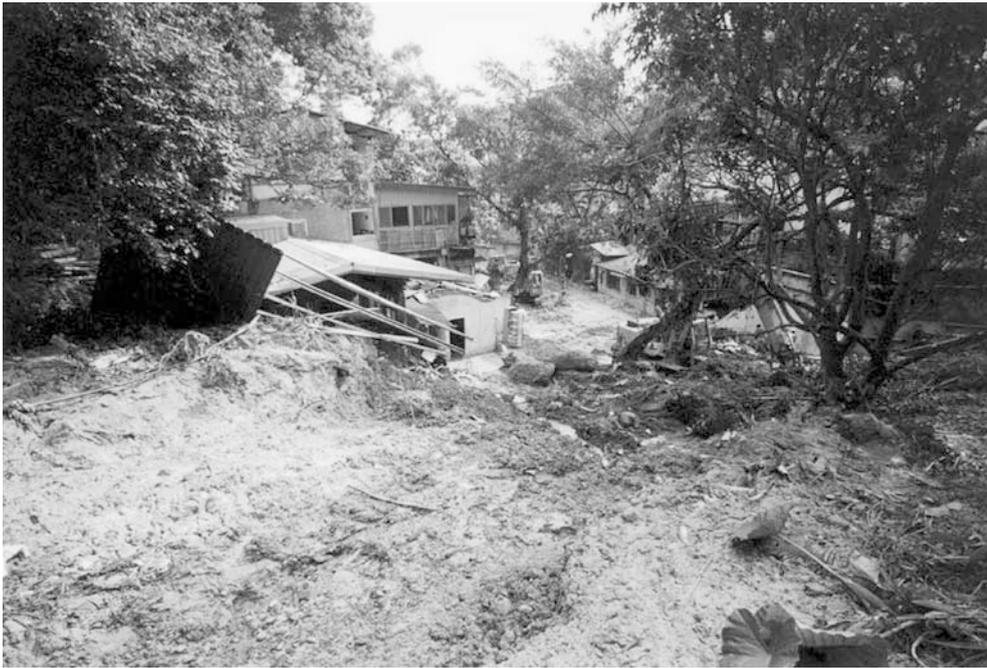
**Fig. 1**  
The hazardous mudflow rapidly flowed down into the community

The disaster area, Neihu, is in the northeastern part of Taipei City in northern Taiwan. In October 16, 1998, Typhoon Zebert dumped more than 300 mm/day of precipitation in this region, causing a hazardous mudflow that resulted in five deaths and damaged three buildings without forewarning (Fig. 1). This funnel-shaped mudflow had a volume of 2,000 m<sup>3</sup>. A man-made platform and construction stood right at the top of the mudflow. Eyewitnesses to this disaster were deeply concerned because the disaster area occurred in the largest city in Taiwan. Enlisting various methods, this study attempts to identify and explain the triggering mechanism of this mudflow.

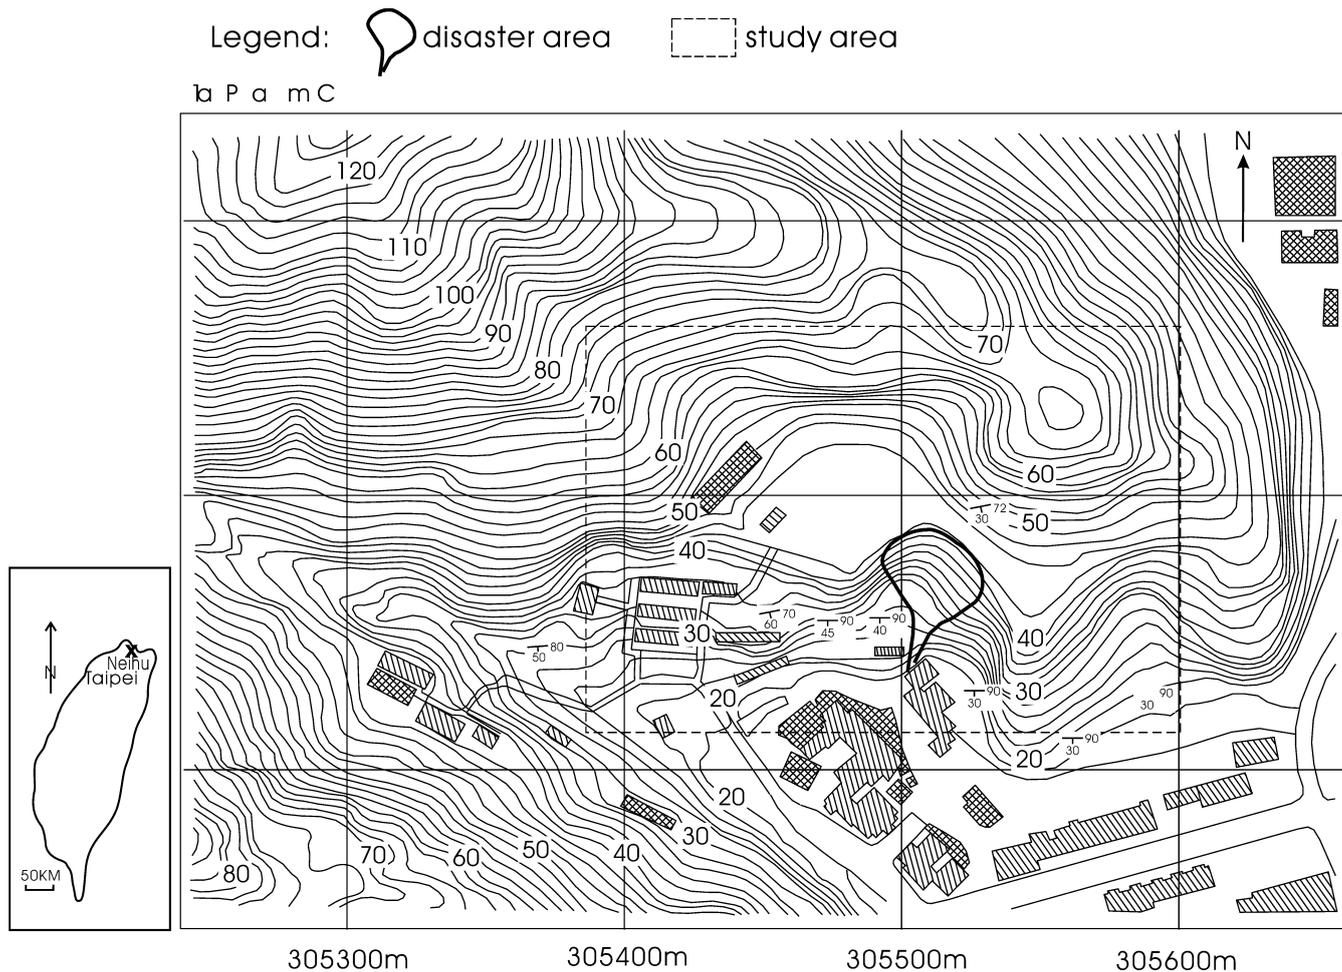
**Fig. 2**

The location and topography map of the study area

The hazardous mudflow was funnel-shaped (Fig. 2), open at the upper part of the mudflow to the north and evacuating downward to the south, causing the geohazard. Five buildings stood right at the exit of the funnel shaped flow. A platform of 30×80 m was distributed at the top of the funnel (Fig. 3). A newly eroded gully was formed along the slope, connecting the entrance to the exit of the mudflow. The dip direction of this gully proceeded from north to south. The width of the gully was around 31 m at the top and 10 m in the central part. The length of the mudflow was approximately 60 m. The flow material particles were mostly less than 2 mm in size and distributed over 80% of the study area. Various thicknesses of the flow material ranged from 1 to 4 m. The basement of the outcrop was revealed in the central part of the erosion gully after the disaster.

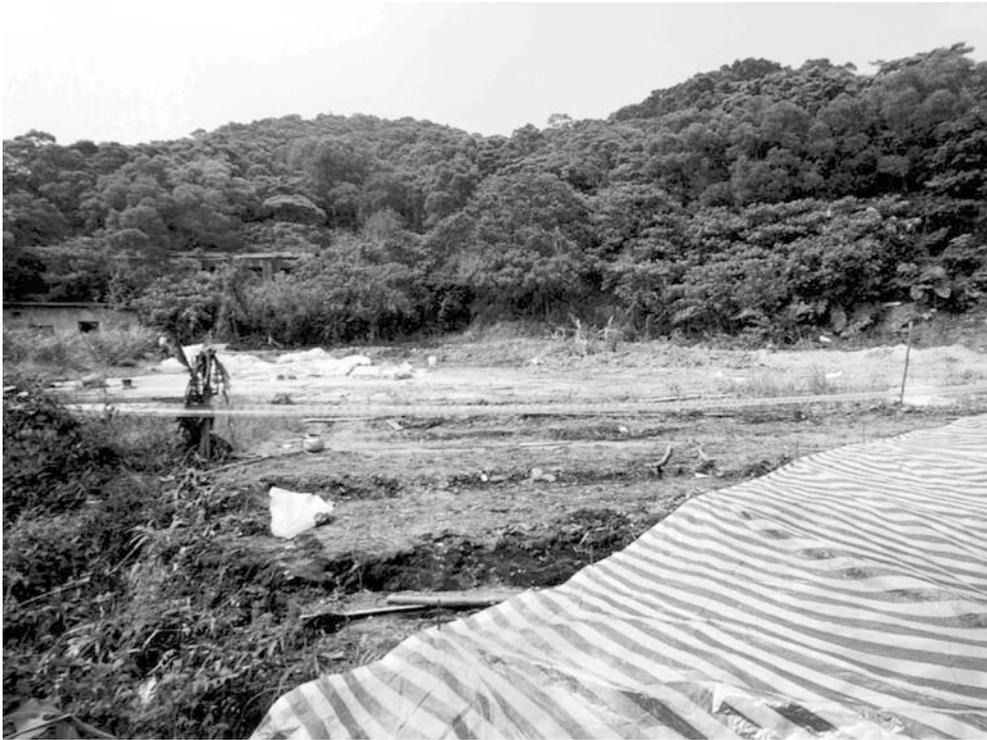
**Fig. 3**

A platform of 30×80 m distributed at the top of the funnel shape area. Several moss layers still clearly appear on the front of the platform surface after the disaster

On-site investigation revealed that several layers of moss still appeared on the front of the platform surface after the disaster. Each moss layer was about 5 to 10 cm in thickness, with some cracks displayed unambiguously beneath the moss. The moss area extended about 50 m in length and 5 m in width on the platform. Consequently, it is known that the water or erosion material did not massively pass through this area—for the moss growth clearly had been growing on the edge of the platform for at least 1 year.

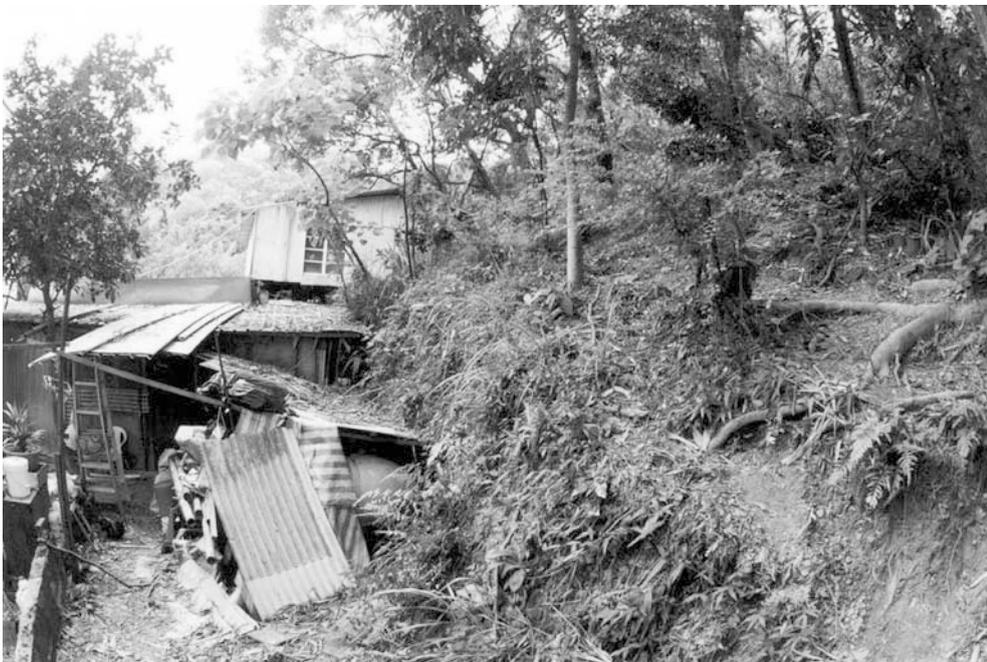
**Fig. 4**

The walls of the two houses barely touched the foot of the hill

The erosion gully is concave shaped, with a slope gradient ranging from 48 to 80%. The walls of two houses are very close to the bottom of the hill (Fig. 4). The near vertical slope at the bottom of the hill ranges from 3 to 5 m in height, higher than the basement of the housing construction. Vegetation has been growing next to the erosion gully for a long time. The erosion gully can be traced by the runoff on the study area. The catchments are around 2.17 ha, and the elevation of the hilltop is 120 m. The slope gradient ranges from 43 to 52%. Various trees and shrubs cover the whole uphill area. Groundwater was still seeping out from the joints in the middle portion of the erosion gully during the on site inspection.

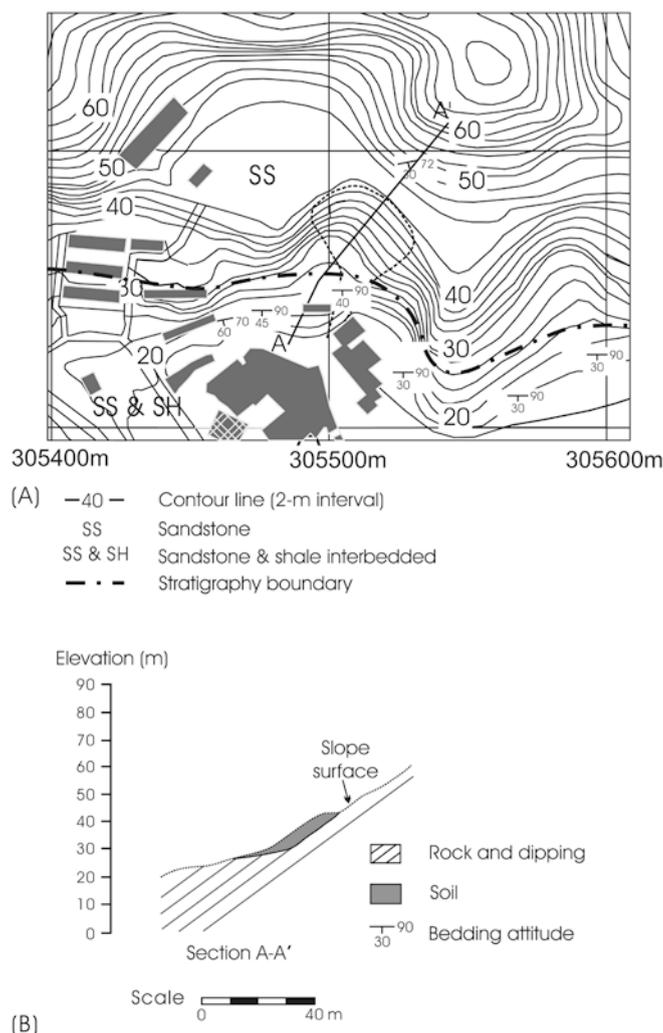
**Fig. 5**  
 The geological map of the study area

The major rock type in the study area is massive sandstone of the Mushan Formation of the early Miocene (Ho 1986). This is mainly quartz sandstone. The thickness of the massive sandstone ranges from 30 cm to 1 m, consisting of nearly 80% medium- to coarse-grain quartz. The rock surface is normally yellowish-brown in colour and looks weathered. Mushan sandstone generally weathers into sandy soil on the ground surface. In the erosion gully, massive sandstone is distributed below, while the upper part is sandstone with embedded shale (Fig. 5). The bedding, which appears in the erosion gully, has a nearly east-west orientation with dip angle ranging from 30

to  $60^\circ$  toward the south. Only one joint N $8^\circ$ W is present, dipping  $84^\circ$  toward the north. The joint orientation roughly parallels the slope surface of the erosion gully. The springs constantly flow from the joint planes in the middle part of the erosion gully. It seems that the joint planes also govern the groundwater channel in the study area.

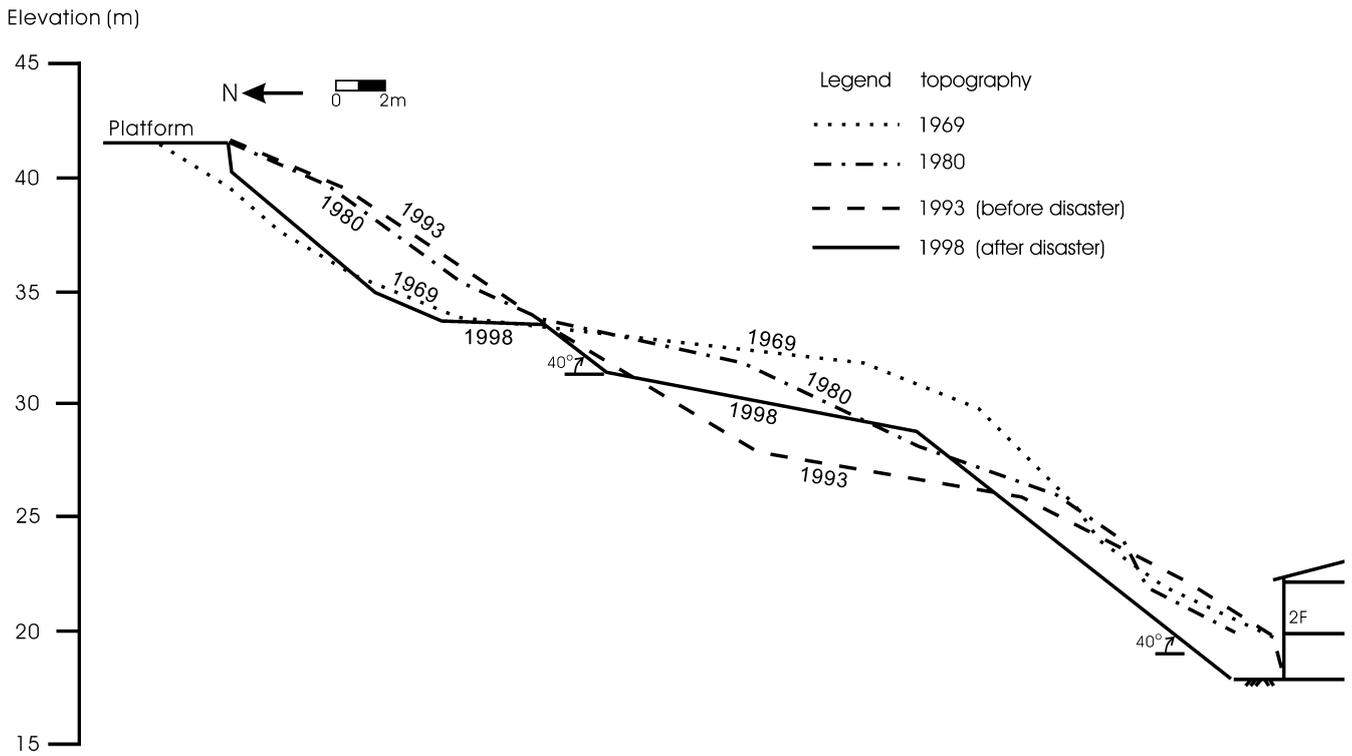
**Fig. 6**  
The cross sections of morphology compositions at four different periods

Contour maps prepared during three earlier periods—1969, 1980 and 1983—were compared with the present topography. The cross sections show that the platform had been set up before 1980.

Originally, a military training space, the platform was constructed with debris material approximately 2 m in thickness by cutting away the ground surface. Debris from the cutting had been dumped directly into the gully below. At the same time an embankment had been set up along the southeast edge of the platform to impede overflow down to the slope and to guide the water into the drainage system. The difference in morphology in the maps shows that the length of the embankment had extended about 50 m from east to west until 1993.

The 1980 map shows that the former erosion gully of the study area originally was oriented from northwest to southeast. By 1993, the upper parts of the gully had formed a concave shape with decreased elevation. The cross sections show that the thickness range in the middle part of the gully had decreased by 4 m, compared to the periods of 1969 and 1993 (Fig. 6). Moreover, the slope gradient of the erosion gully on the upper part increased from  $10^\circ$  in 1969 to  $30^\circ$  in 1993. On-site investigation revealed that the elevation of the slip surface had remained similar to that of 1980. The sliding debris mentioned above probably was material dumped between 1969 and 1980.

The cross sections also display two steps of slope gradient that are distributed on two different horseshoe-shaped slopes. On the upper step, the slope angle ranges from  $15^\circ$  to  $27^\circ$  and the lower step ranges from  $25^\circ$  to  $27^\circ$ . In particular, the slope angle at the very bottom of the hill is more than  $40^\circ$ . Figure 7 displays the present topography mode of the disaster area.

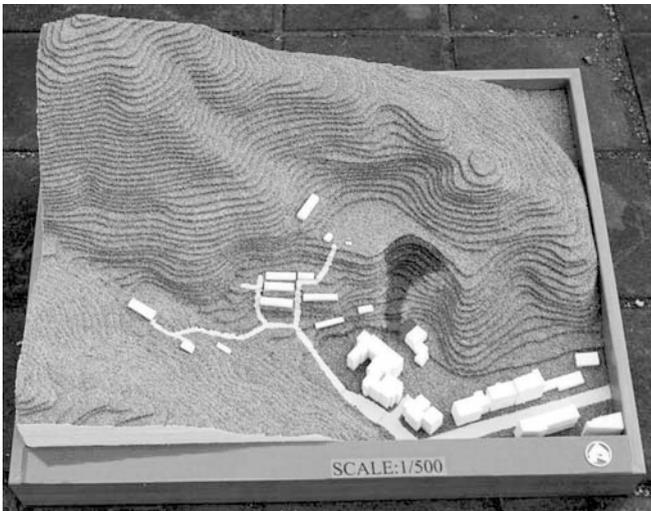
**Fig. 7**  
The topography model displayed the environment of the disaster area

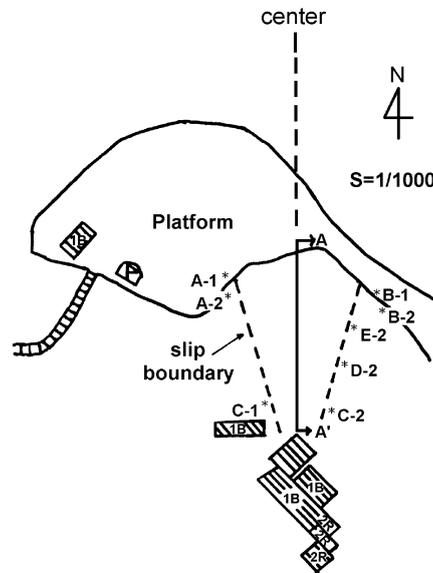
**Fig. 8**  
The locations of the samples taken

Twelve samples for laboratory tests were taken by statically pressing the tube samplers from the upper, middle, lower sections and the west part of the erosion gully

(Fig. 8). Three samples were taken from each part. The purpose of the laboratory tests was to understand the engineering characteristics of the geomaterial in the study area. The results of the tests for engineering properties are shown in Table 1.

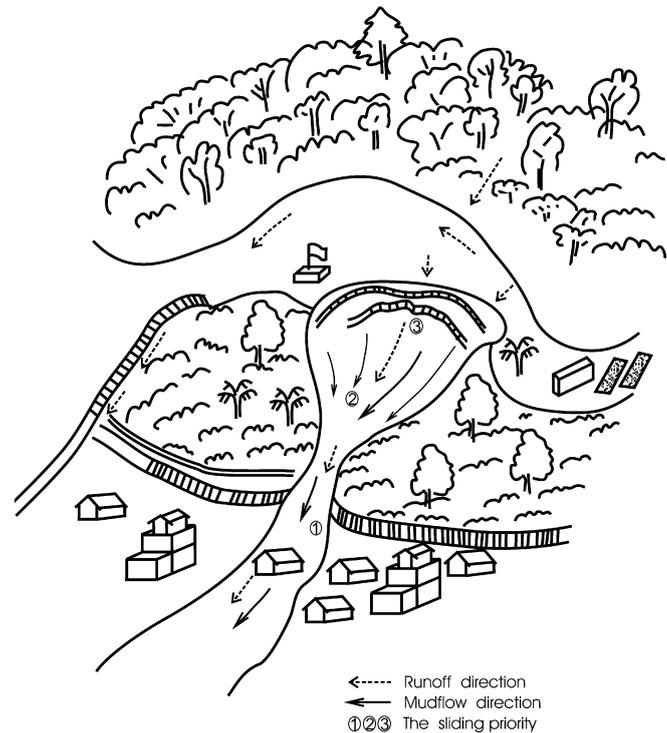
**Fig. 9**  
Failure process simulated diagram of the study area

gully. Secondly, this initial failure triggered a retrogressive sliding in the middle part and then the upper part of the erosion gully (Fig. 9). The initial failure resulted from water accumulated from convergence of hydrological pathways along the catchments. Water was mixed with deposited material from the upper slope channel, which contributed to the transition of an initial landslide into a mudflow.

Initial movements of the mudflow certainly began with the runoff water, where prior rainfall spurred the origination of the mudflow by infiltrating into the hill slope of the study area. Movements accompanying an initial failure let the runoff water mix into the failed material, thus increasing the debris instability (Montgomery and others 2000; Marchi et al. 2002). The failure process proceeded like an upward denudation and kept progressing (Petley et al. 2002). Therefore, the front parts of the platform failed with massive surface water. Finally, it slid downward to the bottom of the gully and precipitated a serious disaster.
